VACANT WAREHOUSE FIRE

Seattle, WA

September 9, 1989

**Vacant Warehouse Fire
One Fire Fighter Killed
Seattle, Washington
September 9, 1989**

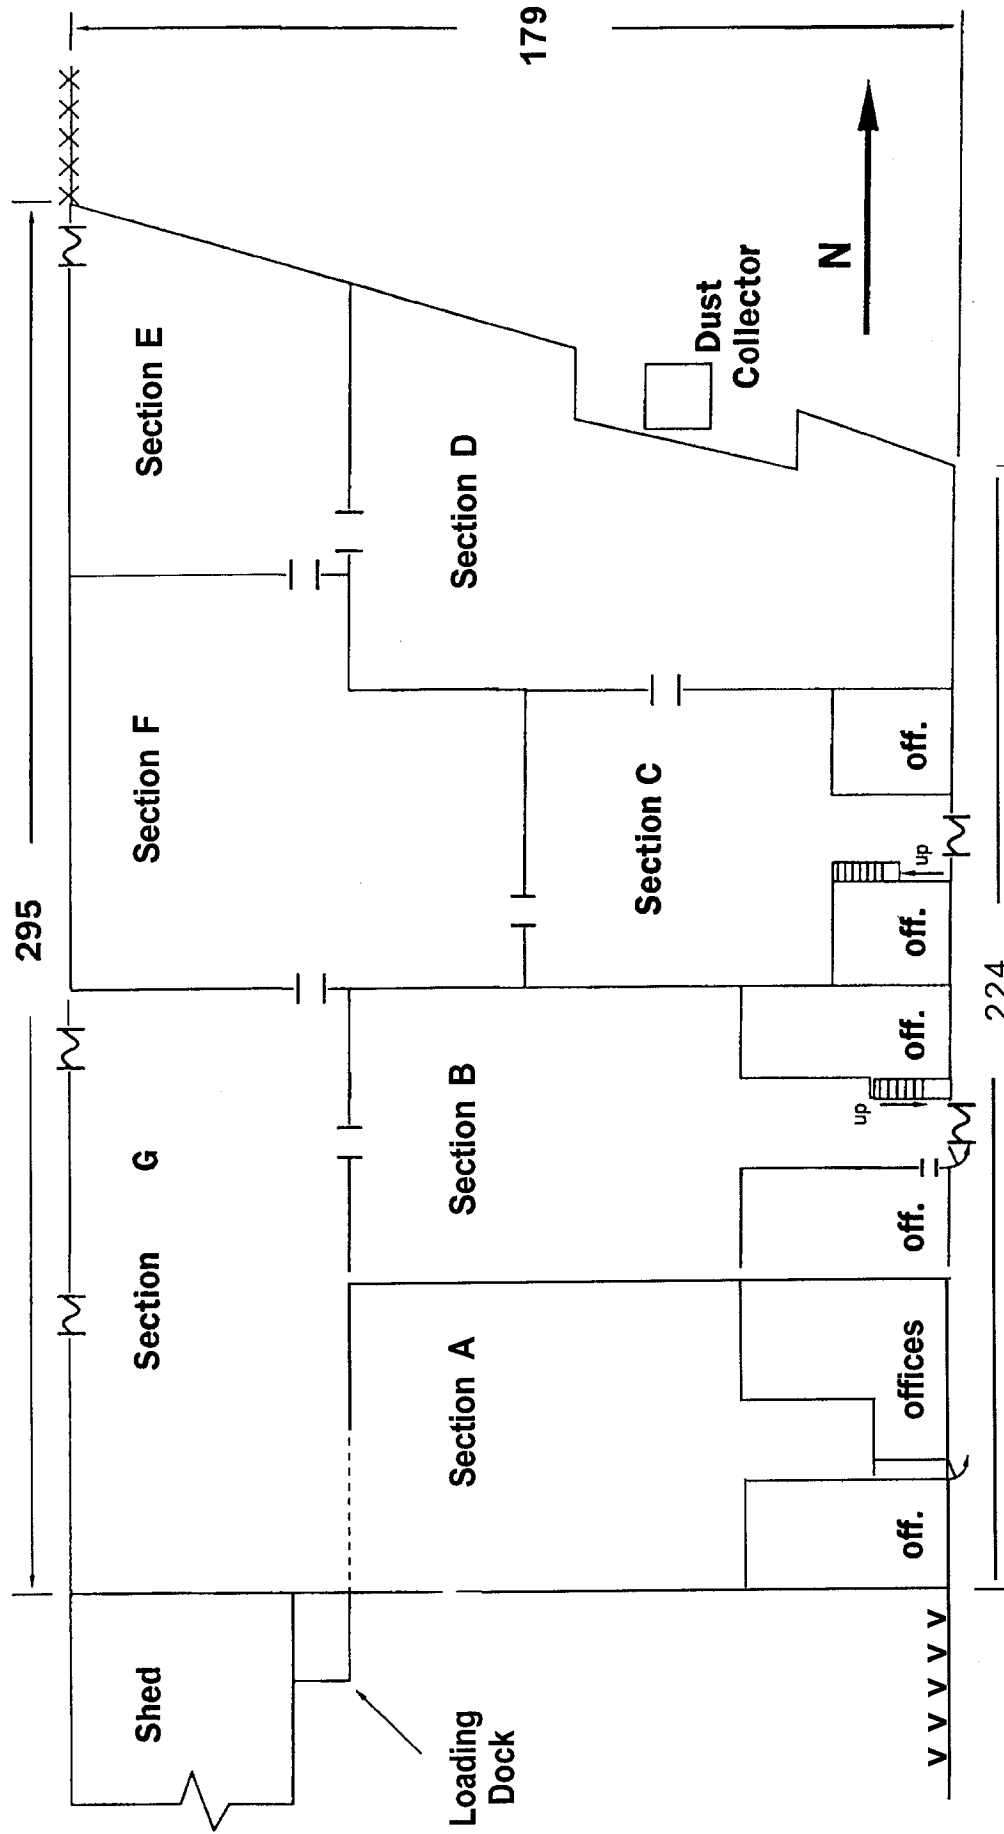
Building Plan View

B-1 arrived on the scene at 9:23 p.m. before any other fire department units. He found a 75 ft X 75 ft shed adjacent to the southwest corner of the building completely involved in fire, and it appeared that the fire could have been extending into the building. (See Figure 2, Appendix B.)

The missing officer was located in Section B, approximately 80 feet from the door he entered and under about two feet of debris. (See Figure 3, Appendix B.) The search took about one hour, and the officer was dead at the time of discovery.
